Corrosion Inspection and Structural Capacity Check of a Steel Pipe Rack Gantry

Identifying Severity of Corrosion, Structural Capacity and Recommendations for Strengthening and Repair

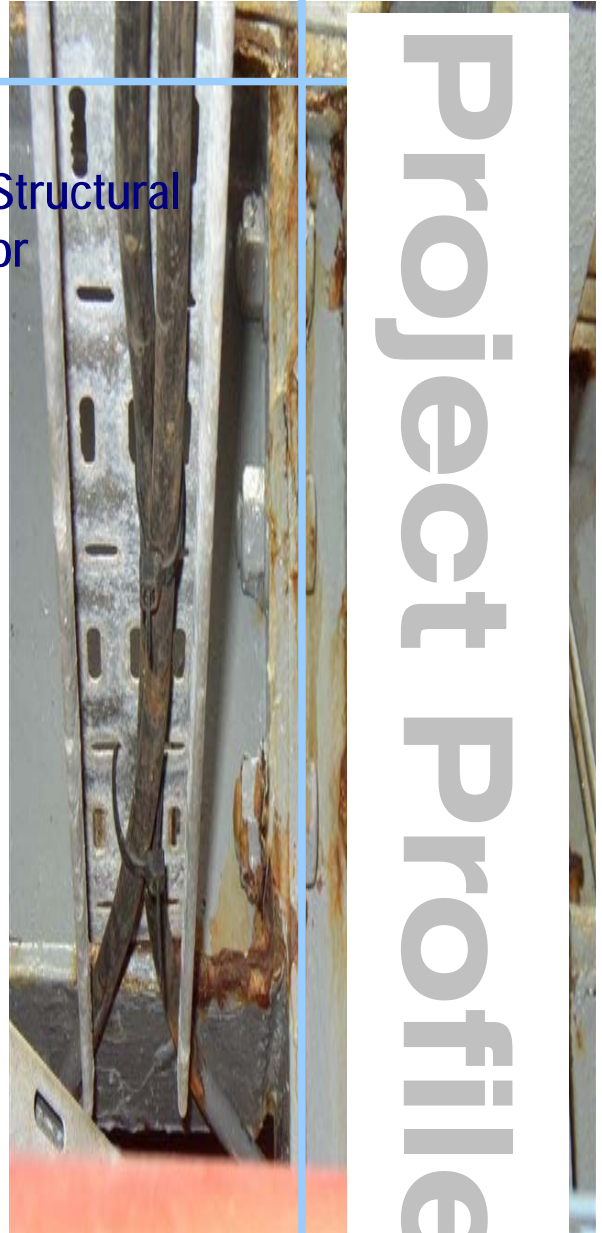
Typical Problems of the Steel Structure

Spot rusting, General rusting, Pin point rusting were identified and methods of corrosion treatment were given. The piperack was found to have failed in structural capacity due to its long span and strengthening methods were provided.
